Intel[®] Itanium[®] 2 Processor

Specification Update

June 2003

Document Number: 251141-013

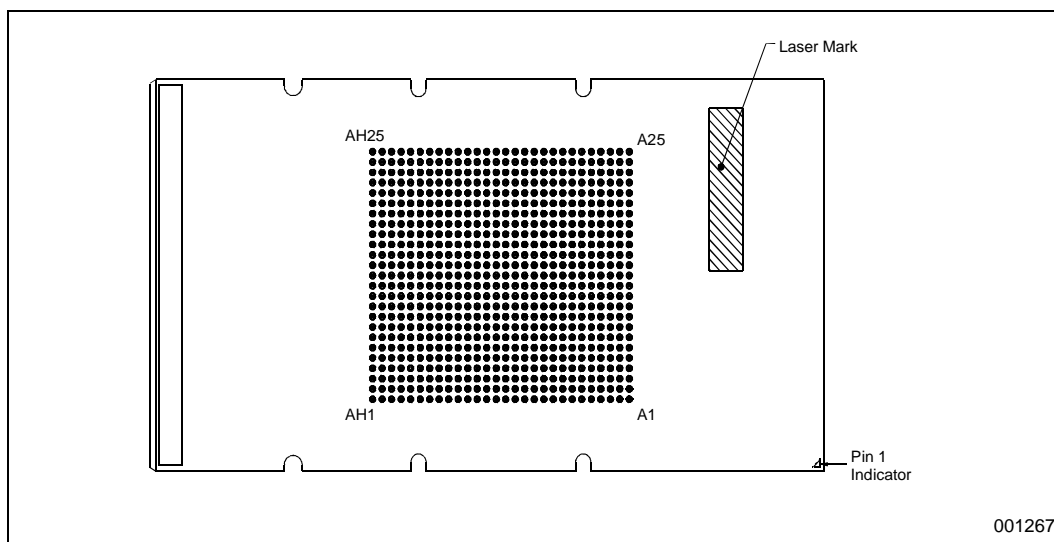
Figure 1-2. Processor Bottom-Side Marking Placement on Interposer

The processor bottom-side mark for the product is a laser marking on the pin side of the interposer. Figure 1-2 shows the placement of the laser marking on the pin side of interposer. The processor bottom-side mark provides the following information:

- Product ID
- Finish Process Order (FPO) Number
- Serial Number
- S-Spec
- Country of Origin
- 2D Matrix Mark included on Itanium 2 processor (up to 6M L3 cache) only. Not included on Itanium 2 processor (up to 3M L3 cache).
